# RE BREEN 2 SOLAR PROJECT

Water Body Site Investigations Report

RE Breen 2 Solar Project

H334680-0000-07-124-0008

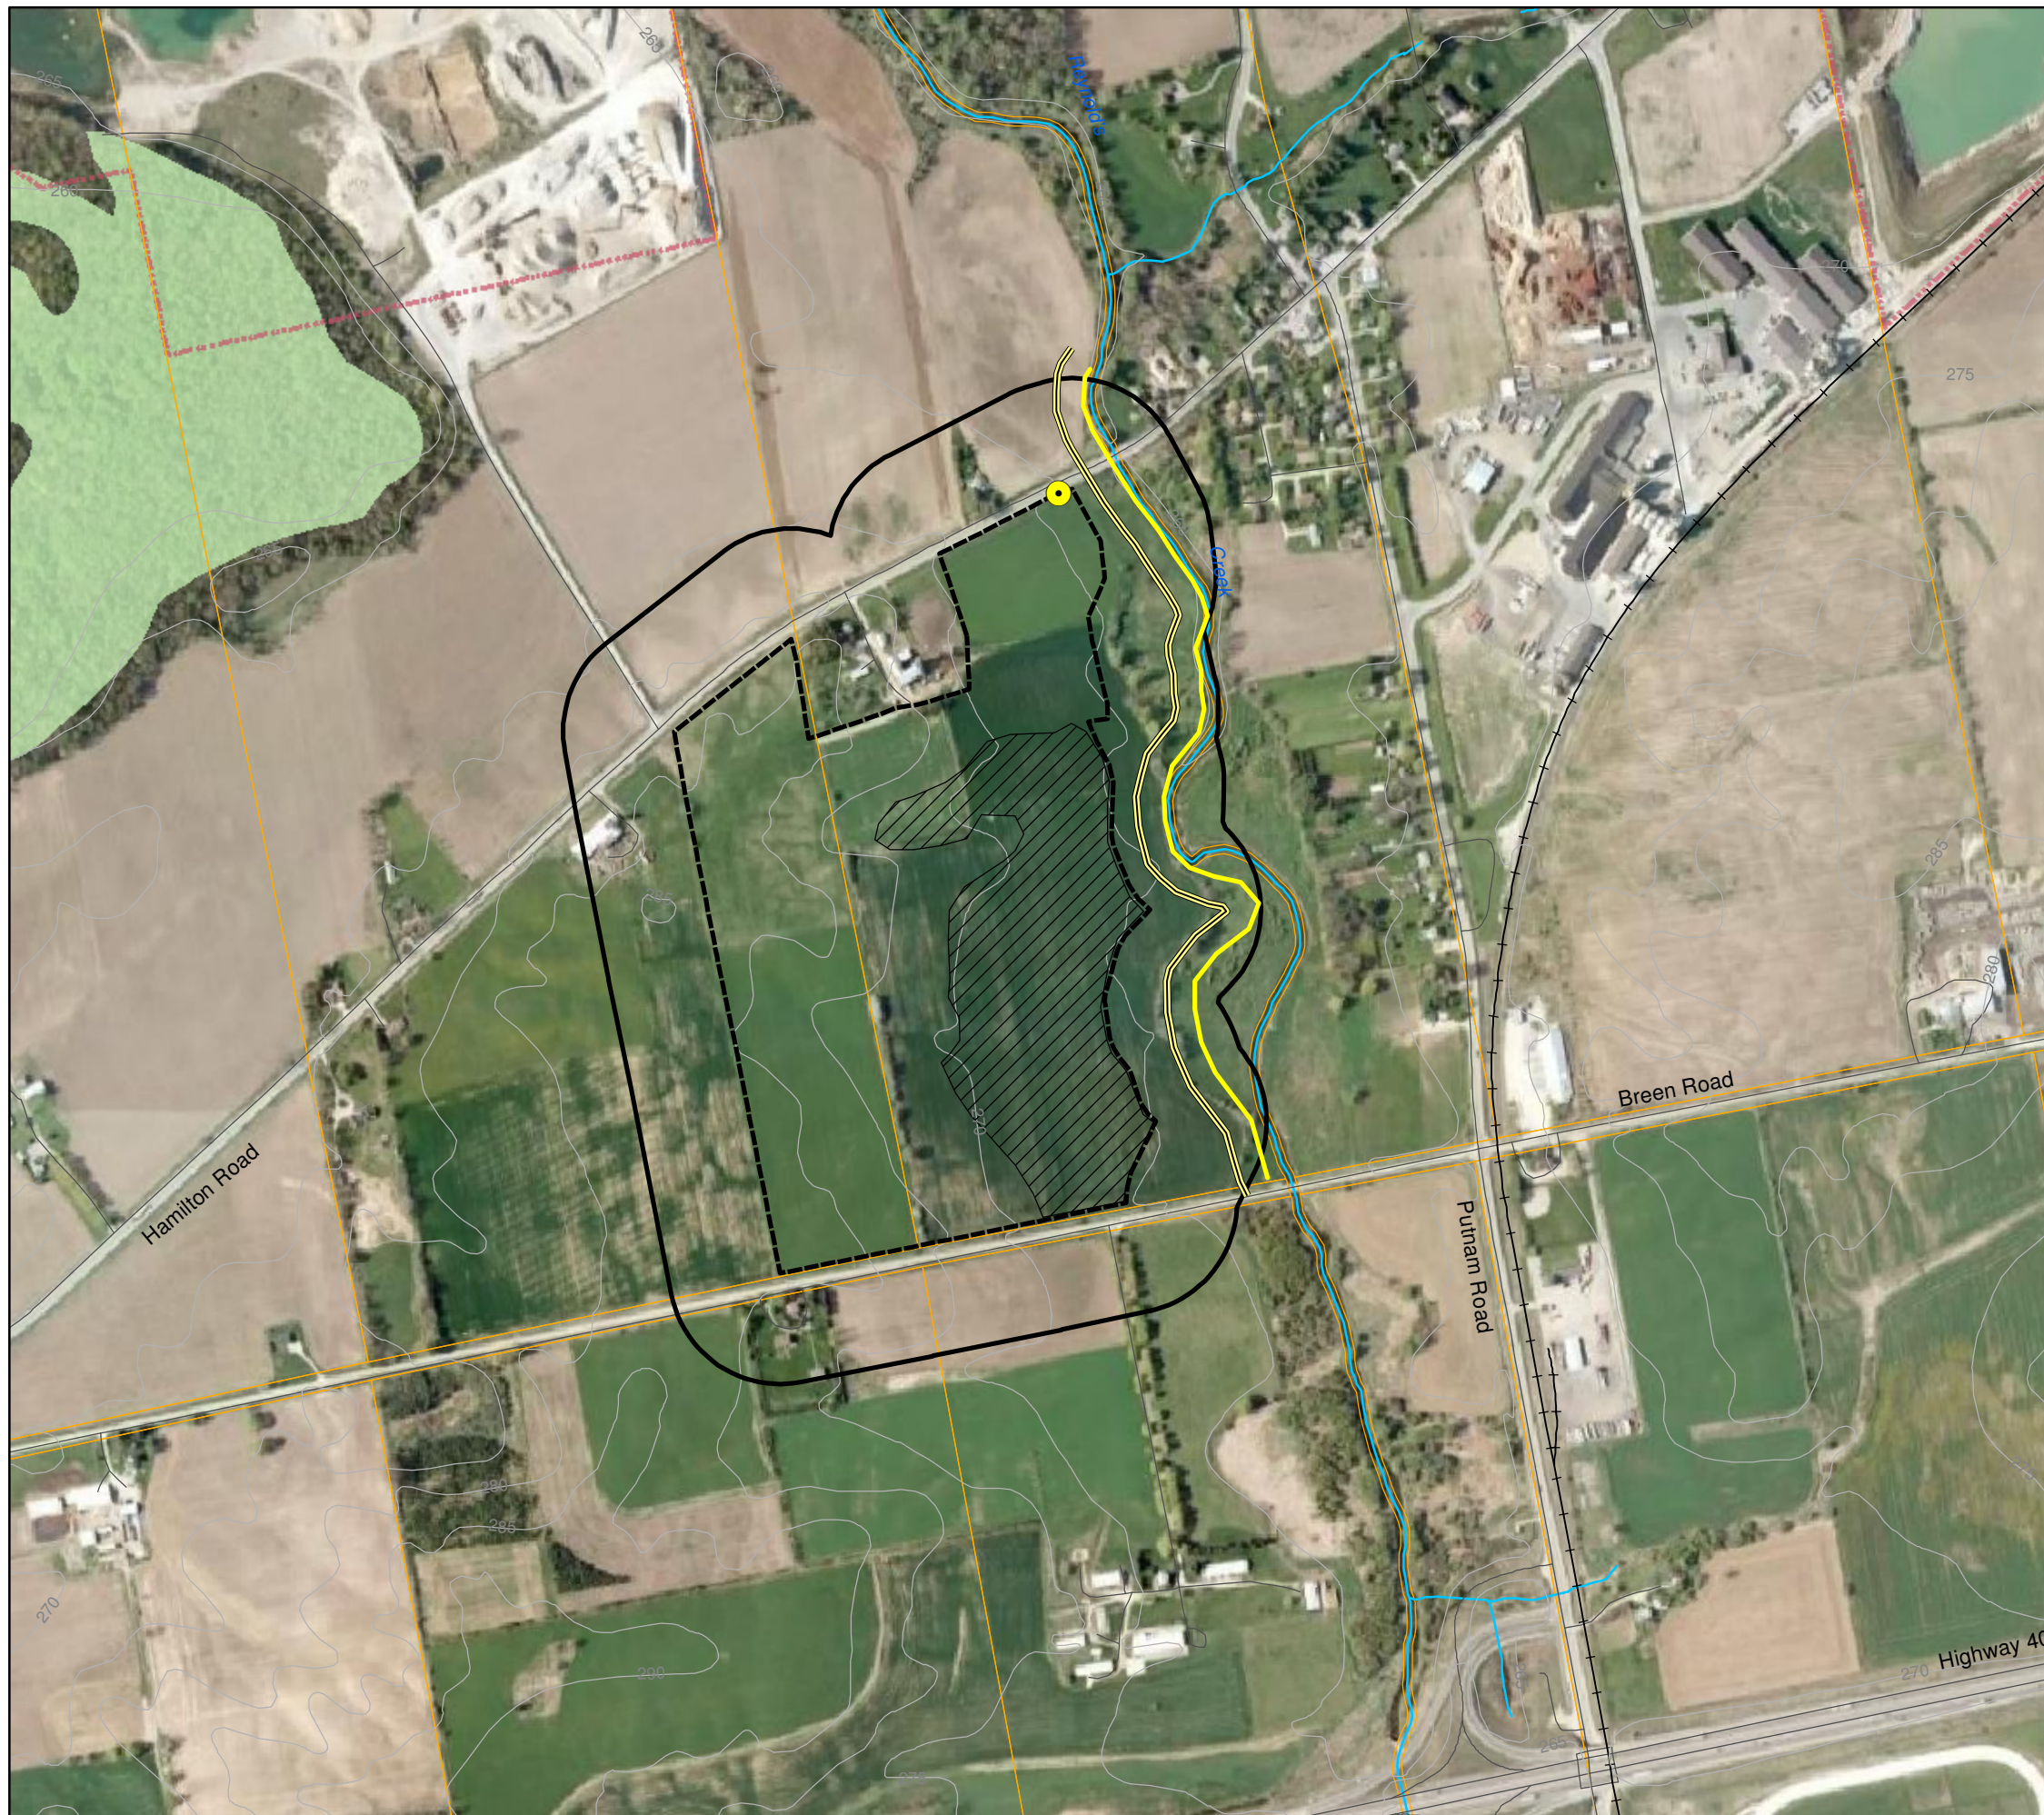
Figure 4.1  
 Recurrent Energy  
**RE Breen 2**  
 Project Location and Water Body Features **HATCH™**

This section documents the results of the Site Investigation and discusses specific water features observed on and adjacent to the Project location. Features noted in the following sections, including the proposed Project footprint boundary, are shown in Figure 4.1.

Therefore, the site investigation has confirmed that Reynolds Creek is a permanent stream and would be classified as a water body, based on the definition in the REA Regulation. The boundaries of the water body would be the average annual high water mark (i.e., the normal water's edge during the annual flood). To establish this boundary, riparian vegetation was assessed to determine the boundary of vegetation species tolerant of annual flooding. Based on this, the average annual high water mark was determined to be the top of the channel bank immediately adjacent to Reynolds Creek, since the riparian vegetation consists of terrestrial grasses and forbs with no affinity for annual submergence. The average annual high water mark boundary is shown in Figure 4.1.

The REA Regulation requires solar panels, transformers and inverters to be set back at least 30 m from the water body boundary (i.e., the average annual high water mark). Therefore, the distance from the water body boundary to the Project footprint will be 30 m, particularly in the northeast corner of the Project area, where development activities will occur up to the 30-m setback. However, this distance will be increased along the majority of Reynolds Creek, since the high water mark meanders away from the Project boundary in a number of locations. In addition, restrictions on development of prime agricultural lands limit the extent of the Project in proximity to Reynolds Creek, as shown in Figure 4.1.

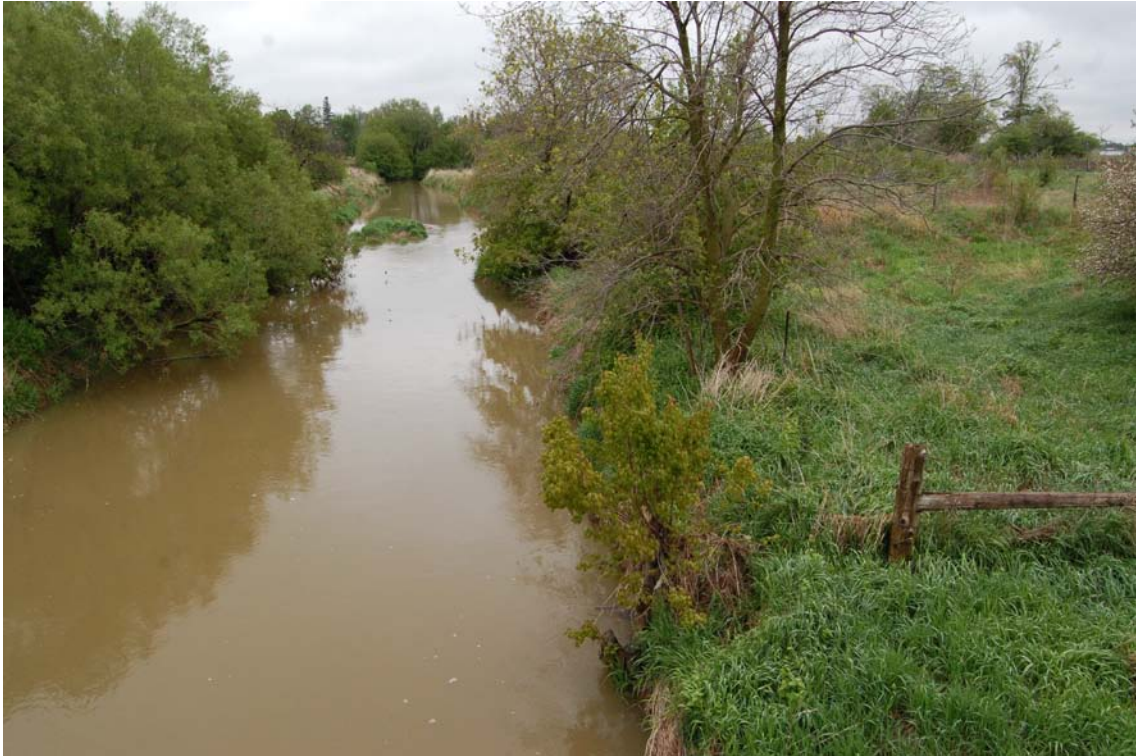
**Figure 4.2 Reynolds Creek Adjacent to the Project Location –  
View Downstream from Hamilton Road**

The riparian corridor includes the creek channel itself and surrounding low lands. The creek channel was approximately 10 m wide, consisting primarily of relatively low gradient, slow moving run type morphology (Figure 4.2). UTRCA (2007) notes that a total of 20 fish species, including game fish species such as largemouth bass (*Salmoides micropterus*) and brown trout (*Salmo trutta*), and six mussel species have been recorded in the Reynolds Creek watershed. Greenside darter (*Etheostoma blennioides*), federally designated as a species of Special Concern, have been found in the creek (UTRCA, 2007).

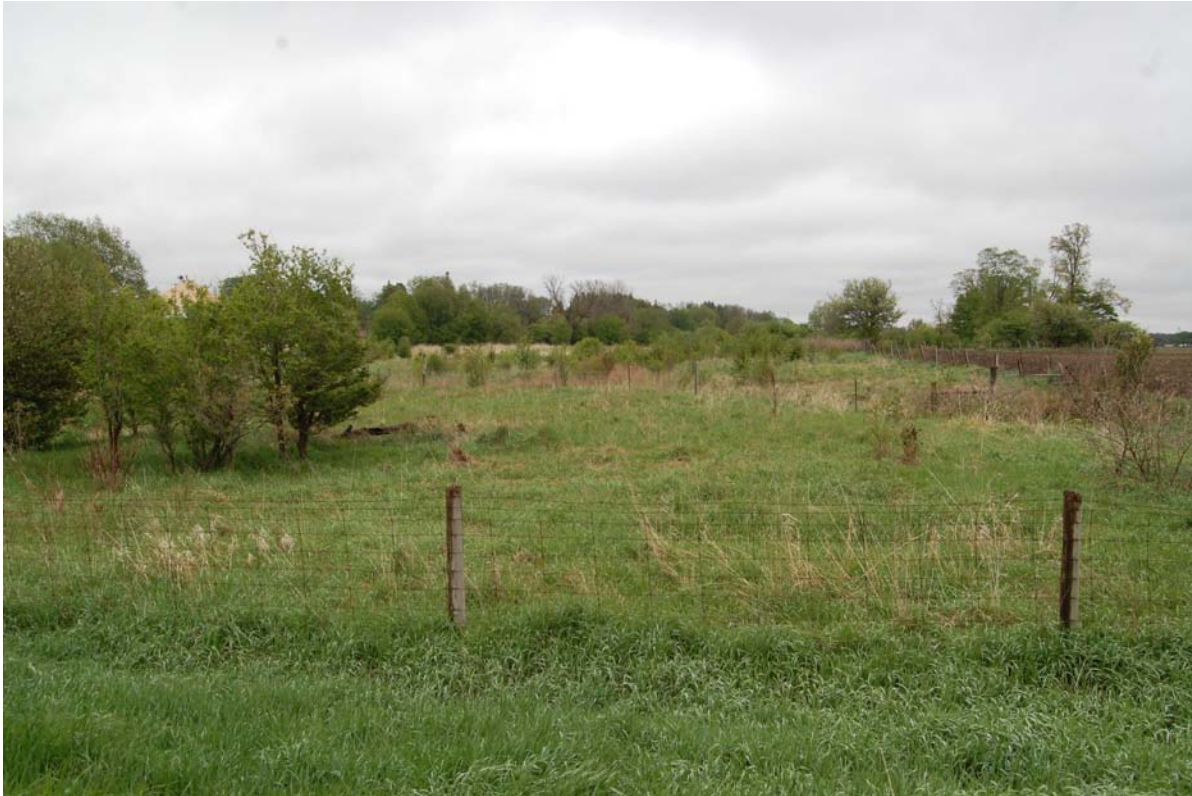
**Figure 4.3 Riparian Vegetation Between Reynolds Creek and the Project Location**

During the site investigation, the vegetation community within the valley was classified as primarily meadow community, with a small amount of pastureland near the southern portion of the Project location (UTRCA, 2008). The portions in the meadowland are composed primarily of grasses, with scattered shrubs/trees (as is seen in Figure 4.3). The vegetation community of the riparian area is primarily terrestrial type vegetation, and is not indicative of any annual flooding.

The primary natural functions of both the meadow and pastureland portions of the valleyland is to provide protection for Reynolds Creek by stabilizing the surrounding banks, providing potential for absorption of pollutants from runoff, and providing habitat for terrestrial and aquatic species. The valleyland would also provide a natural corridor for wildlife movement.
