RE ORILLIA 3 SOLAR PROJECT

Water Body Site Investigations Report

RE Orillia 3 Solar Project

H334680-0000-07-124-0091

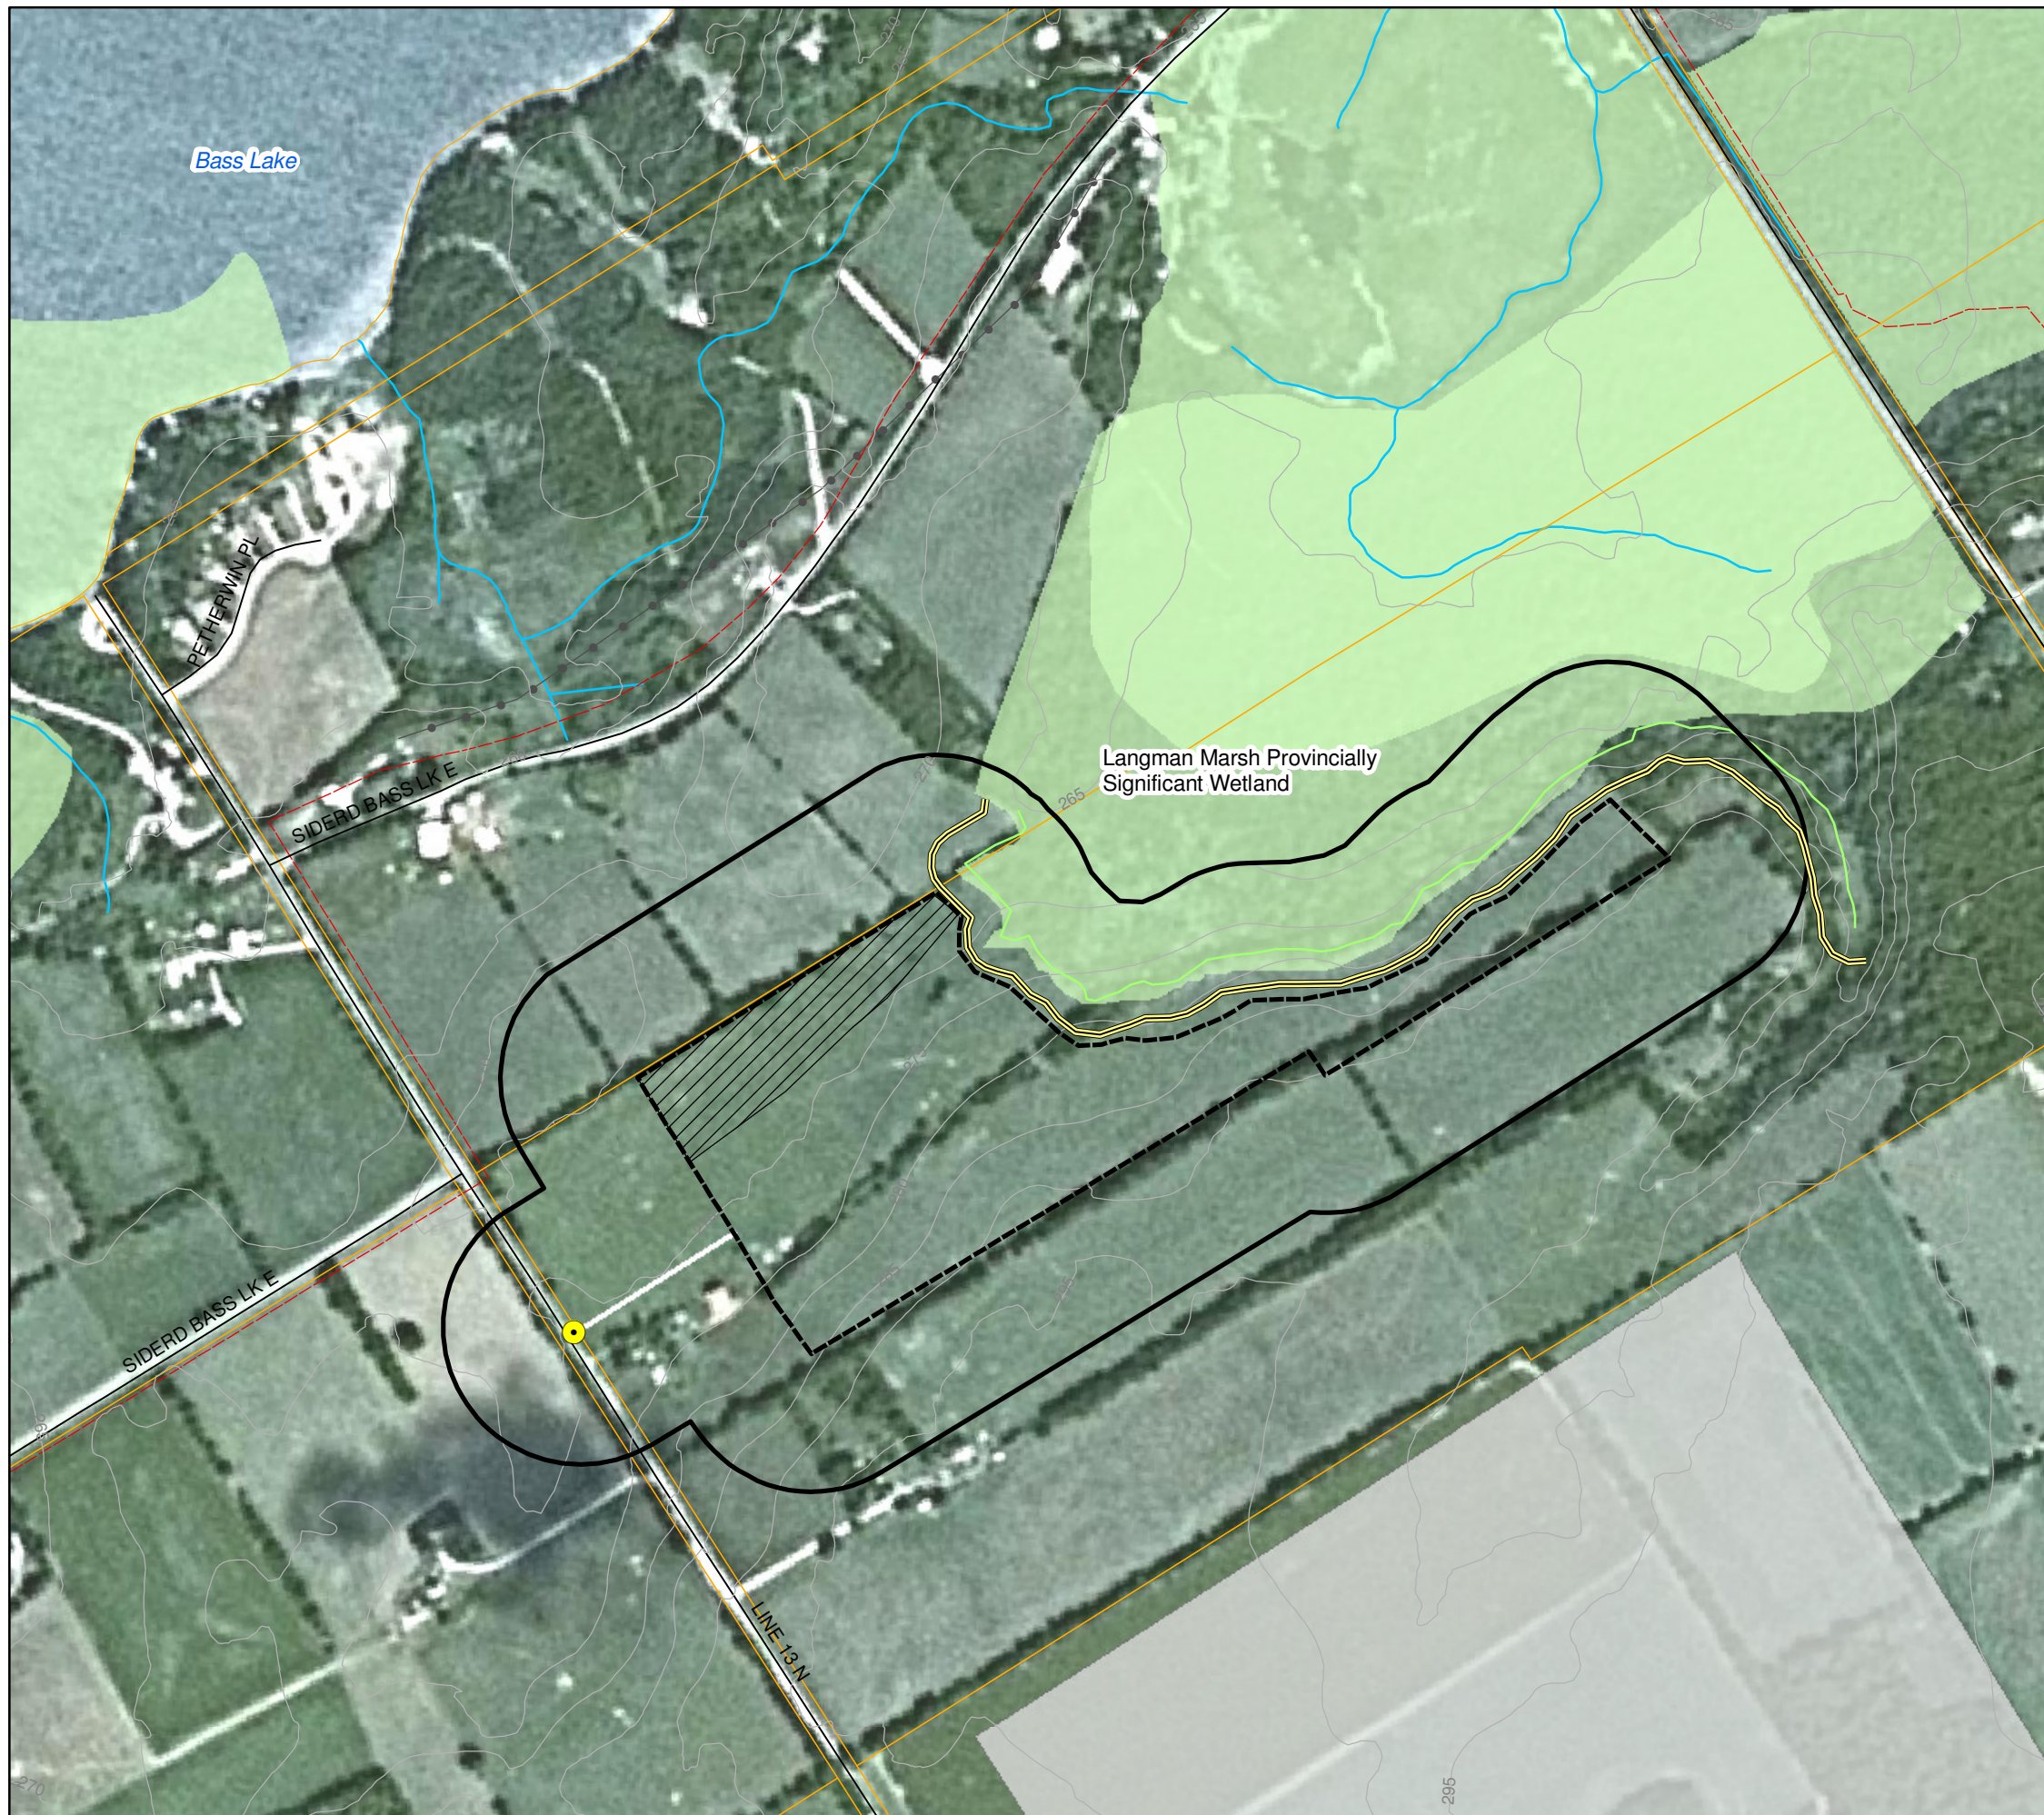
Figure 4.1
 Recurrent Energy
RE Orillia 3
 Water Body and
 Project Boundaries **HATCH™**

No permanent or intermittent streams were observed on or within 120 m of the Project location. As noted in the Water Body Records Review Report (Hatch Ltd., 2010a), the closest watercourse to the Project location is a stream associated with Langman Marsh Provincially Significant Wetland (PSW), approximately 210 m northeast of the Project boundary (as shown in Figure 4.1).

As noted in the Water Body Records Review Report (Hatch Ltd., 2010a) and shown in Figure 4.1, the existing Langman Marsh PSW boundary is located approximately 250 m away from the Project boundary and an unclassified wetland adjoining to the Langman Marsh PSW is located within 120 m of the Project boundary.

Therefore, the seepage area boundary, as shown in Figure 4.1, was assessed as being the base of the slope adjacent to the agricultural fields. This corresponds with the revised wetland boundary shown in Figure 4.1. The REA Regulation requires that a 30-m setback remain between the Project footprint and identified seepage areas. Therefore, this setback will encroach onto the Project location, forcing the solar panels to be set back farther from the woodlot edge than they would be if there was no groundwater seepage.

Based on the results of the site investigation and the proposed Project components and boundaries shown in Figure 4.1, some components of the Project will be located between 30 and 120 m of this seepage area. Therefore, an Environmental Impact Study (EIS) will be required to assess the potential effects of the Project and the required mitigation measures.

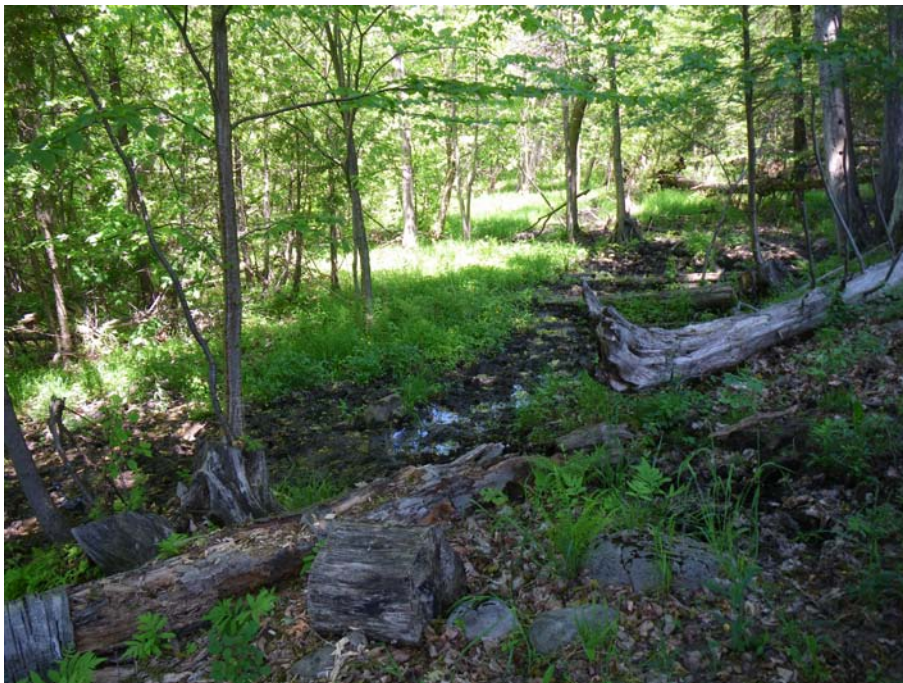
Figure 4.2 Photograph of Typical Wetland Ground Conditions with the Woodlot Adjacent to the Project Location

The woodlot north and east of the Project location commences at the same topographic contour as the agricultural fields of the Project area. A short distance into the woodlot (< 10 m) the ground surface descends over a relatively short distance to a flatter lowlands area. The ground surface in this lowland part of the woodlot was moist with some wet areas during the May site investigation. Wetland vegetation became more predominant in this section of the woodland and the area appears to be a generally wet extension of the adjacent Langman Marsh PSW. As discussed in the Natural Heritage Site Investigations Report for this Project (Hatch Ltd., 2010b), the wetland boundary was revised on the basis of the presence of this wetland vegetation, as shown in Figure 4.1. A photograph of typical wet ground conditions within this woodlot is shown in Figure 4.2.

Given the general wetness of this area at the base of the slope from the tableland agricultural fields and the fact that it contains wetland vegetation and is situated in relatively close proximity to a known wetland, it is possible that this area is fed by groundwater seepage from below the adjacent tablelands, comprised of the Oro-Moraine and a generally high groundwater table in the lowland area. As noted in the Records Review (Hatch Ltd., 2010a), Langman Marsh and Bass Lake receive much of their hydrological input as groundwater discharge from the Oro-Moraine.
